TITLE: 4" 206 SERIES FEMALE x MALE x MALE HAMMER UNION TEE

PART NUMBER: **HUFMM2064T**

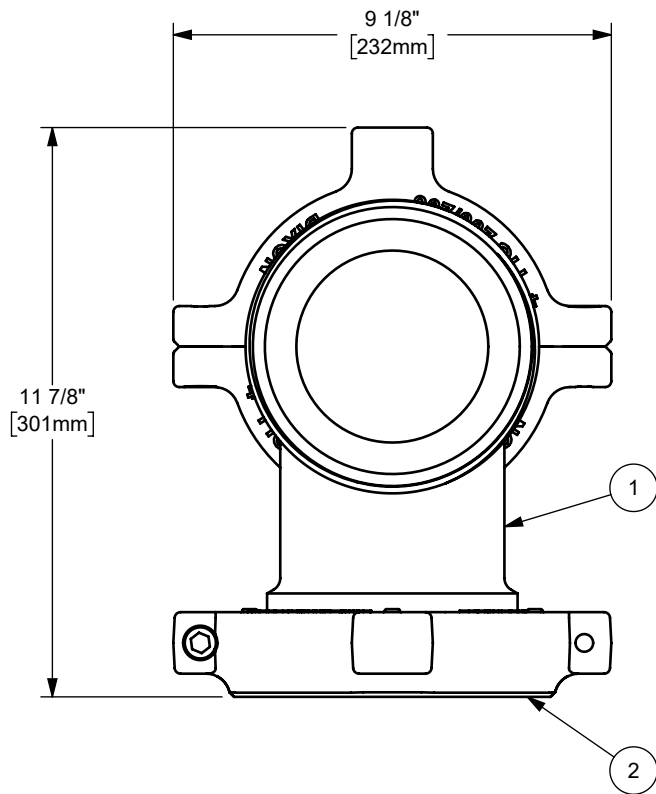
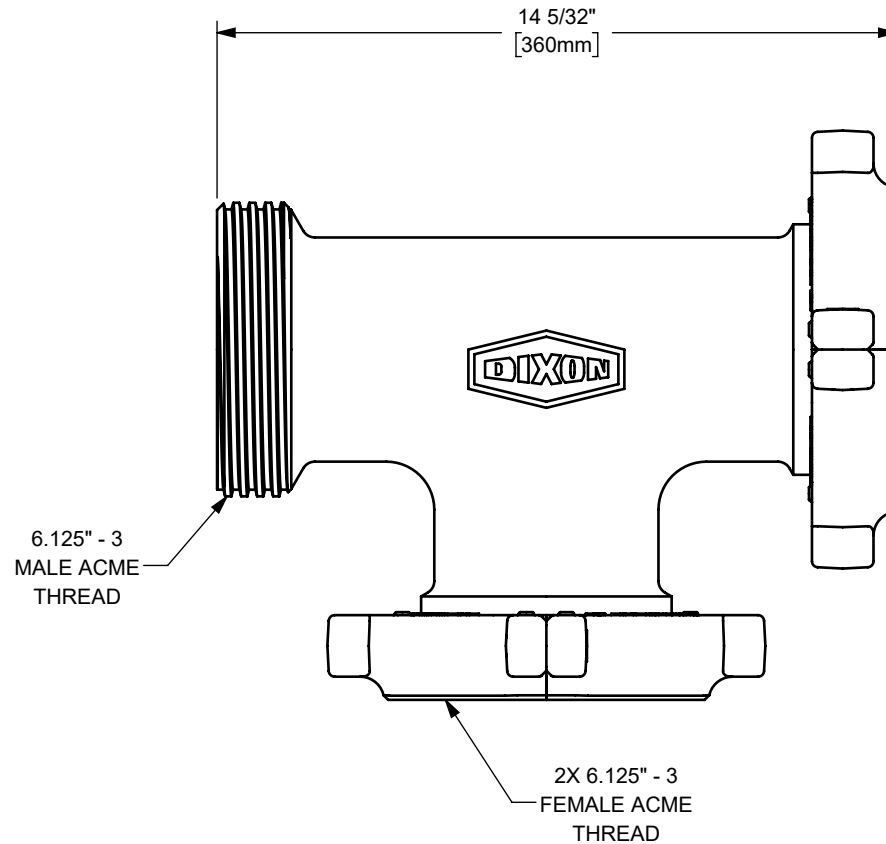
- 1) O-RING (ITEM 3) NOT SHOWN.
- 2) CONTACT SALES FOR REPLACEMENT PARTS.
